K/P-6197, Rev. 1

INVESTIGATION OF A URANIUM HEXAFLUORIDE
RELEASE INCIDENT ON SEPTEMBER 17, 1975,
IN THE K-1423 TOLL ENRICHMENT FACILITY

Oak Ridge Gaseous Diffusion Plant

April 16, 1986

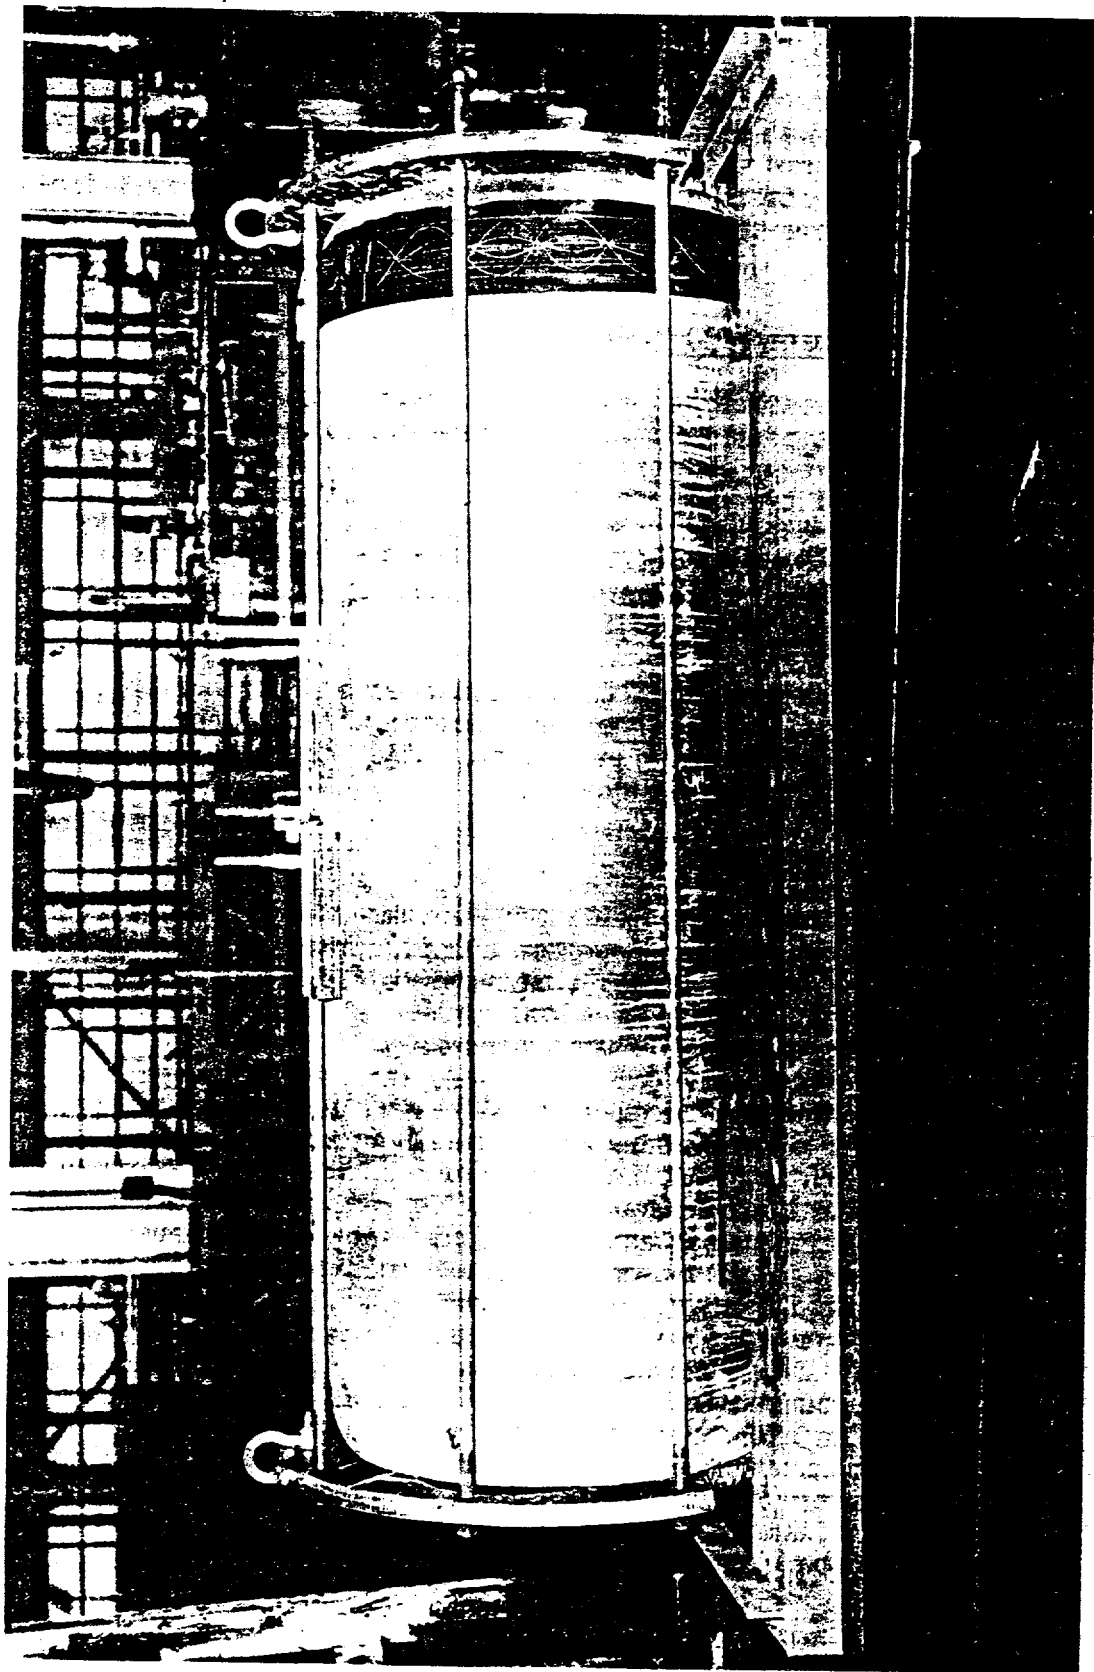
PHOTO NO. 75-3118

Figure 5
DAMAGED CYLINDER WITH END PLATES AND RODS

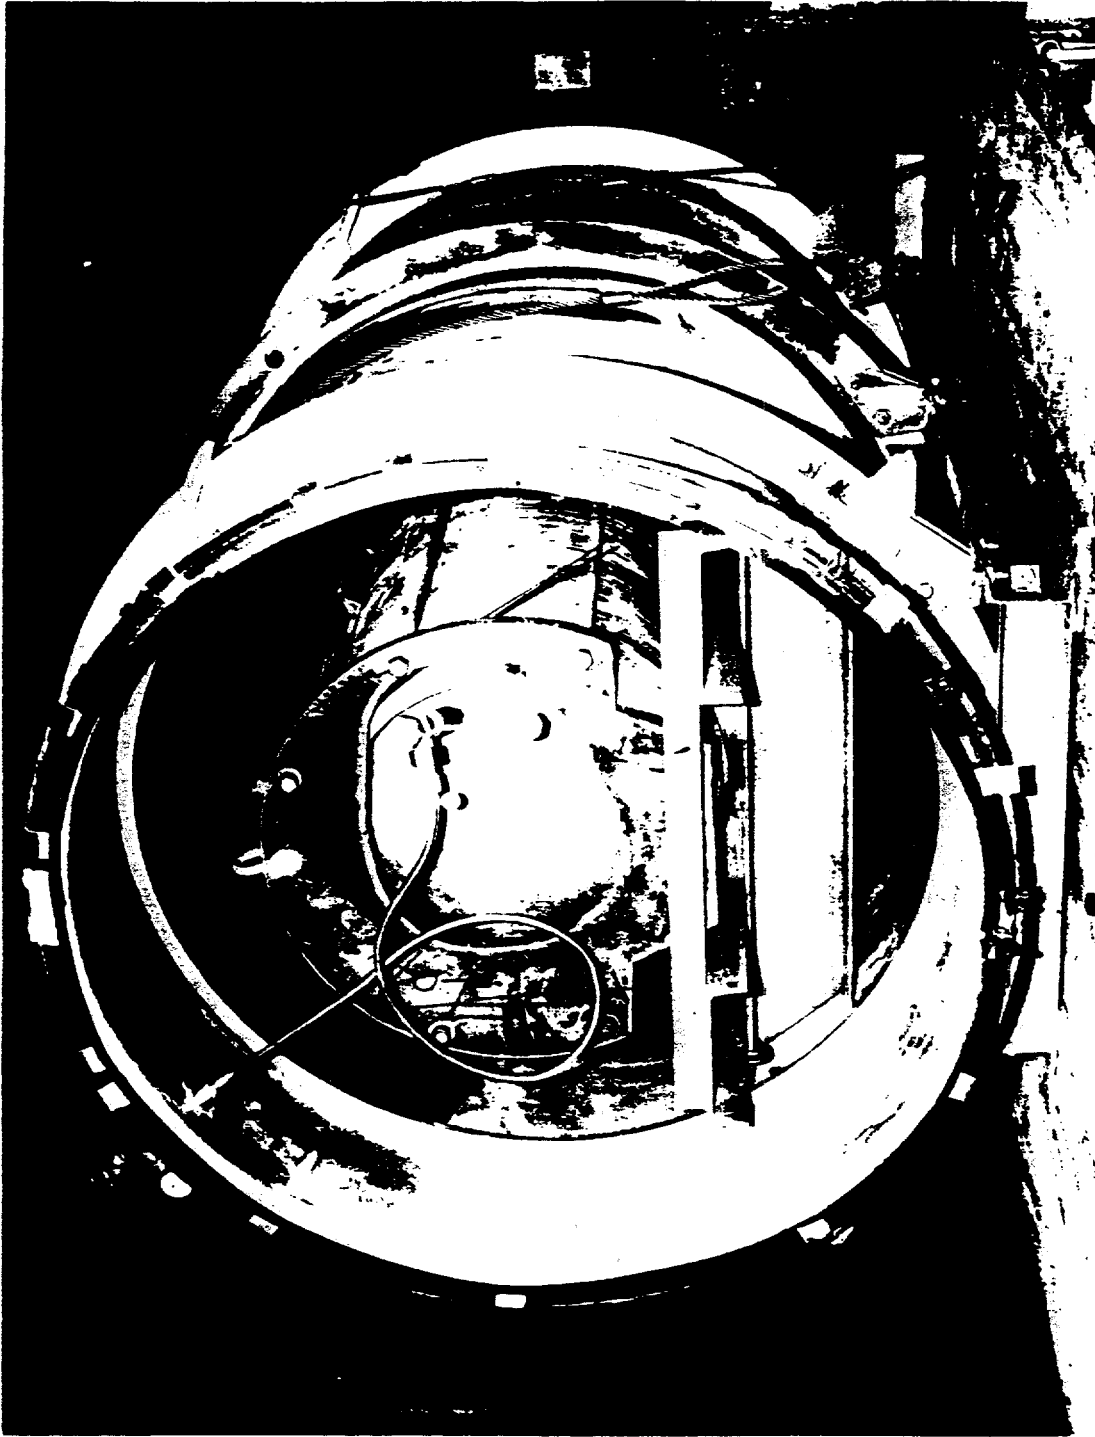
PHOTO NO. 75 3116

Figure 7
SECONDARY CONTAINMENT FOR DAMAGED CYLINDER

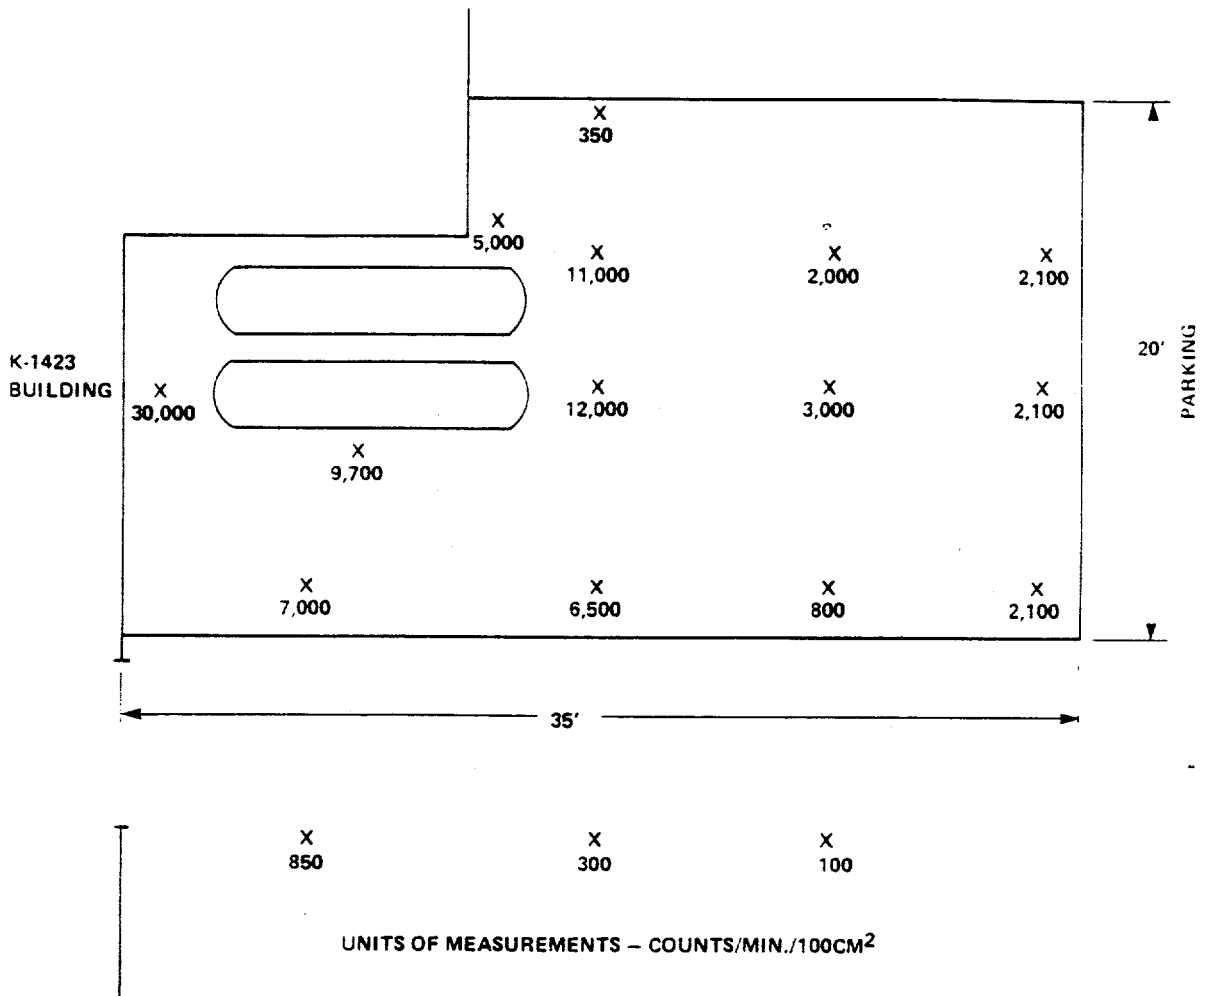
DWG. NO. G-75-894
(U)

12. Alpha radiation surveys of the area following the incident indicated that contamination above 500 counts/min/100 cm² was limited to an area within a 20-ft radius of the damaged cylinder.

CONTAMINATION LEVELS PRIOR TO CLEANUP K-1423

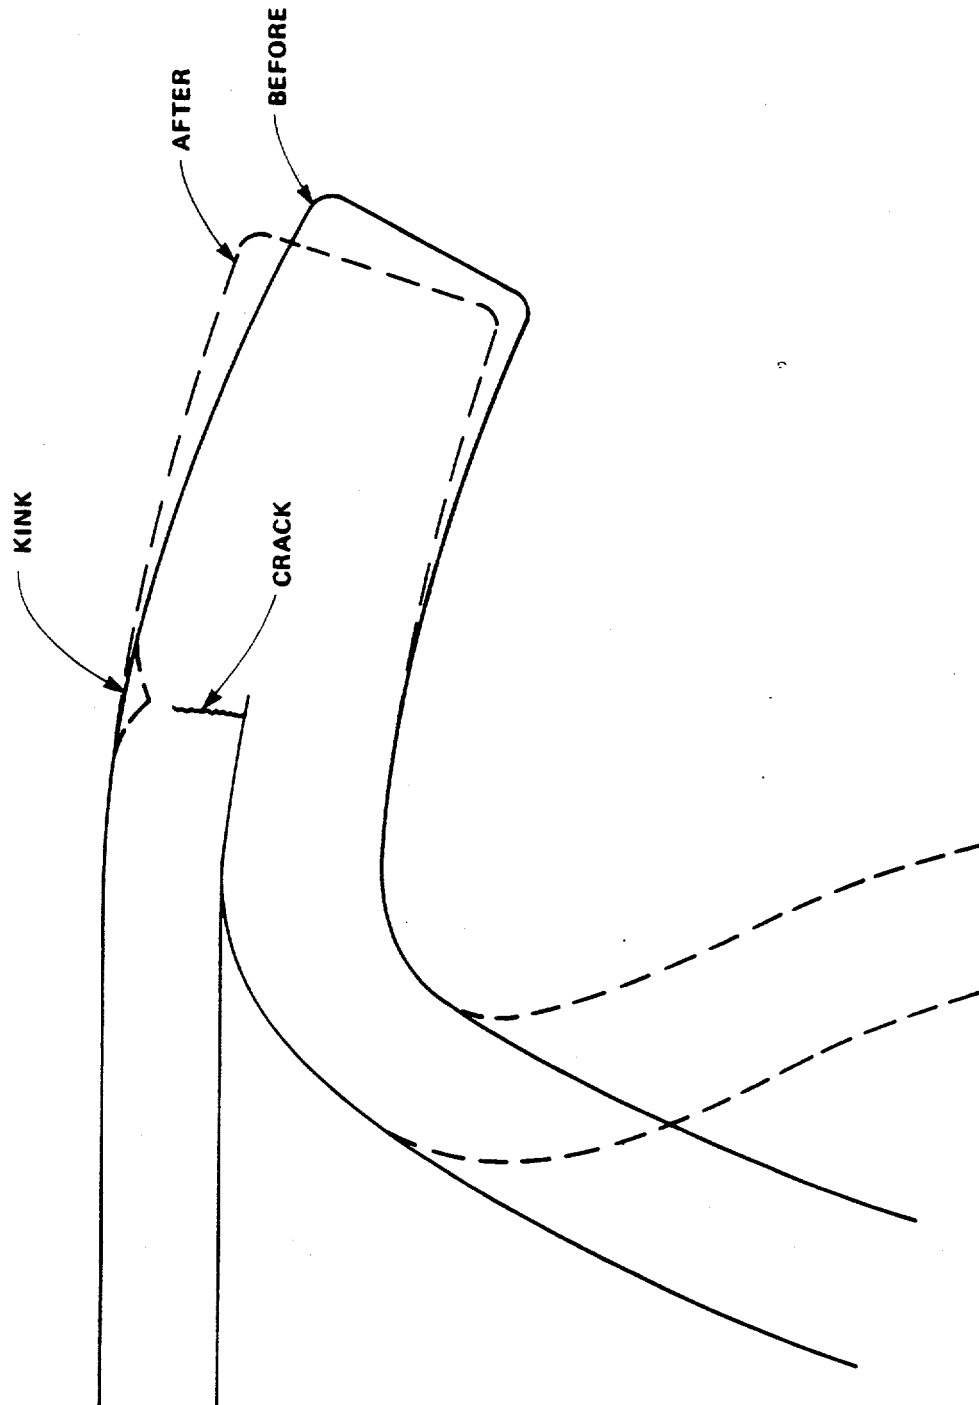
DWG. NO. G-75-893
(U)

Examination of Damaged Cylinder: Visual examination of the area near the crack in the cylinder wall revealed the presence of a buckle or kink in the wall extending about three-fourths of the total circumference of the cylinder. This kink suggested the presence of a crack in this area. Radiograph, dye penetrant, and ultrasonic examinations of this area confirmed the existence of the crack over at least 20 inches of circumference with additional indications being present but inconclusive.

DEFORMATION AND CRACK LOCATION AT PLUG END OF CYLINDER

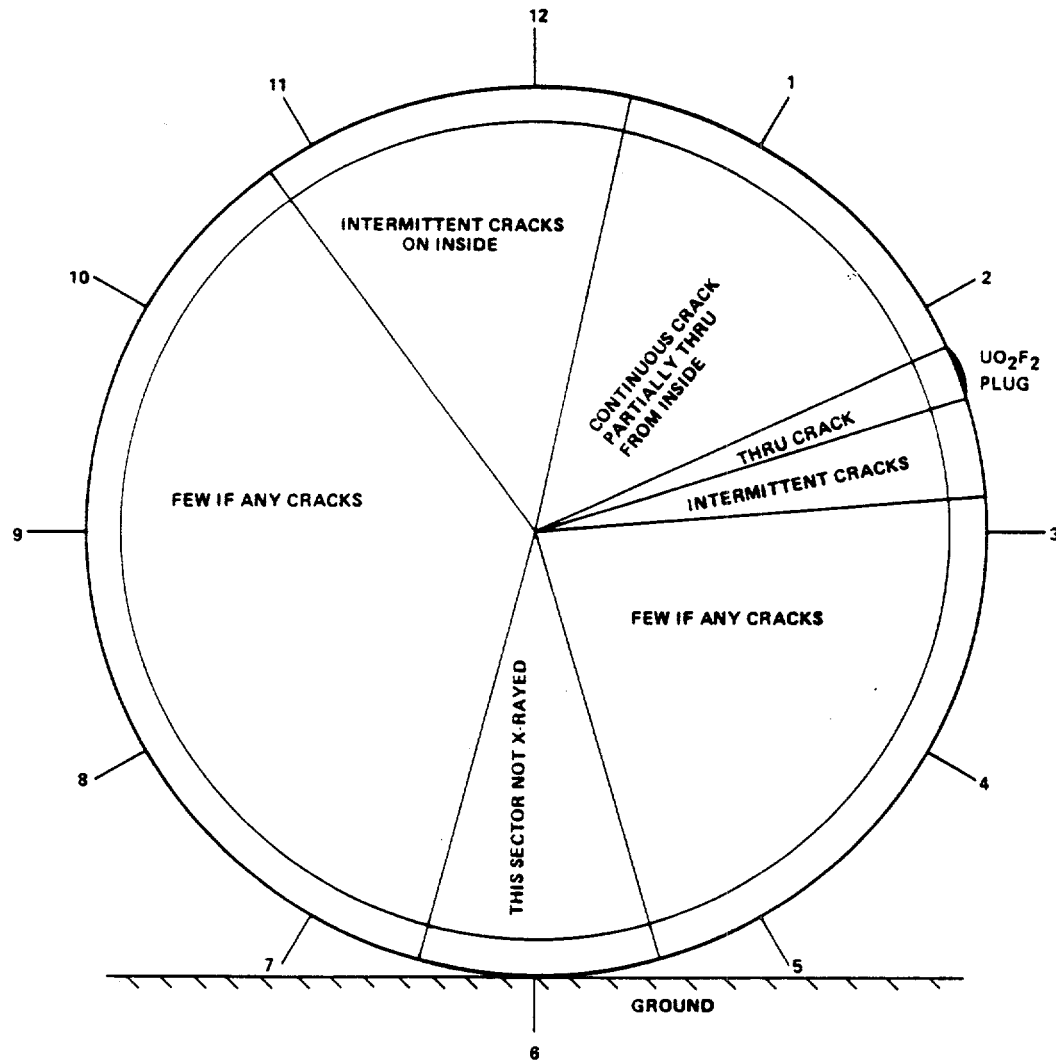
DWG. NO. G-75-896
(U)

Figure 2
CRACK LOCATIONS AT PLUG END OF CYLINDER AS DETERMINED
BY RADIOGRAPHIC EXAMINATION

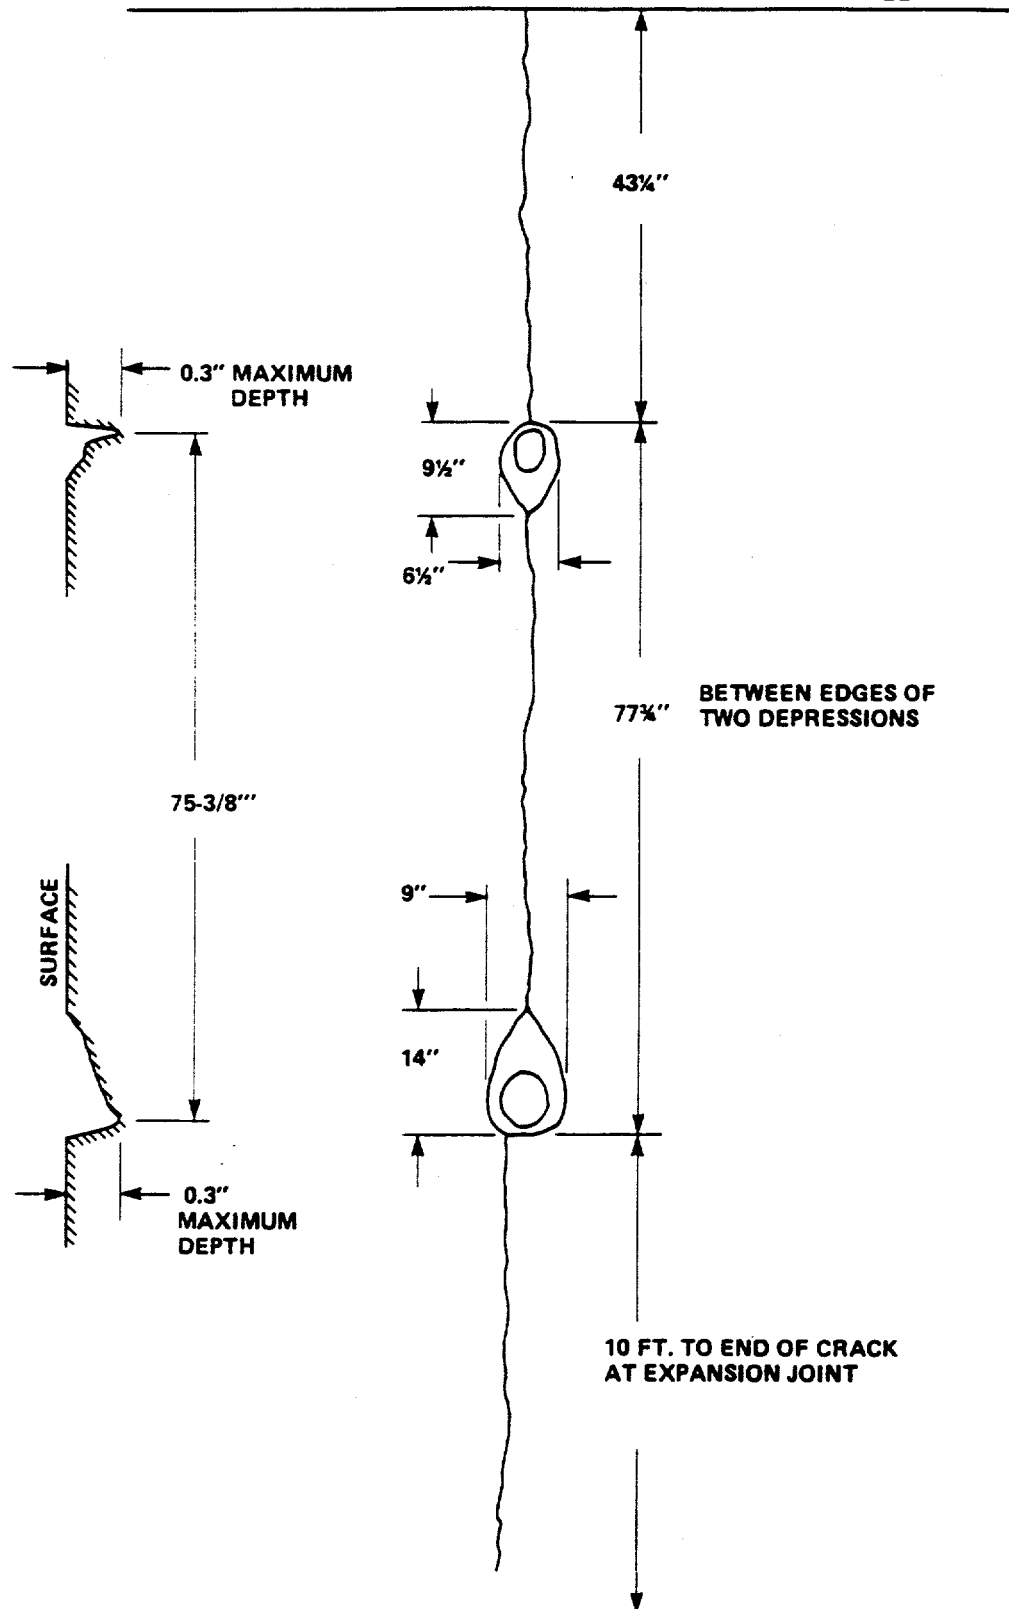
Figure 14

SCHEMATIC ILLUSTRATION OF DAMAGE TO CONCRETE PAD
